<b>Subjects</b>	<b>Initial characterization of soils and processes of solid paving stone and slab sections</b> Phase # 1.0 to 6.0 - Budget #2A (2015-08-27) and services offered (2015-09-15) <b>&amp;</b> <b>Monitoring of instrumented patio sections</b> Phase # 1.0 to 5.0 - Budget #2B (2015-08-27) and services offered (2015-09-15)
-----------------	----------------------------------------------------------------------------------------------------------------------------------------------------------------------------------------------------------------------------------------------------------------------------------------------------------------------------------------

Monitoring report of patio performance measured and built according to the conventional system and Gator Base

## 1.0 INTRODUCTION

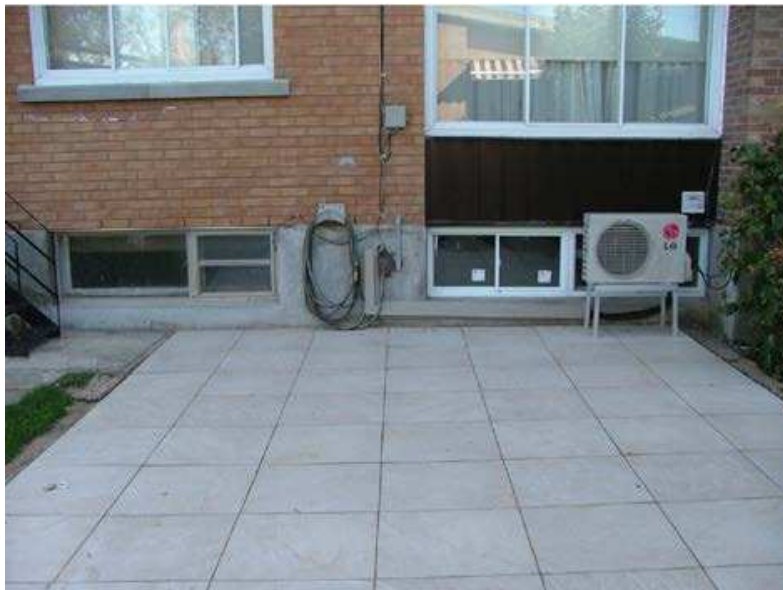
**Picture 1 67 Roxton Crescent in Montreal West - Backyard patio position 308° N.W. Surrounded by house wall and air conditioning unit and a cedar hedge at the back and opposite side of the house.**

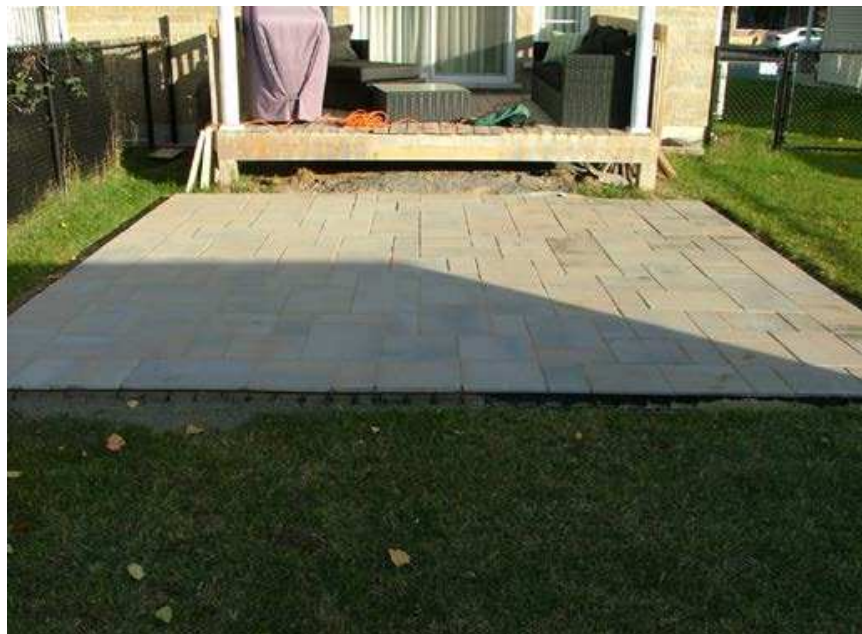
**Picture 2** 114, Daigneault Street in the city of Chambly - Backyard patio position at 145° S. E. The balcony of the house is open on 3 sides.

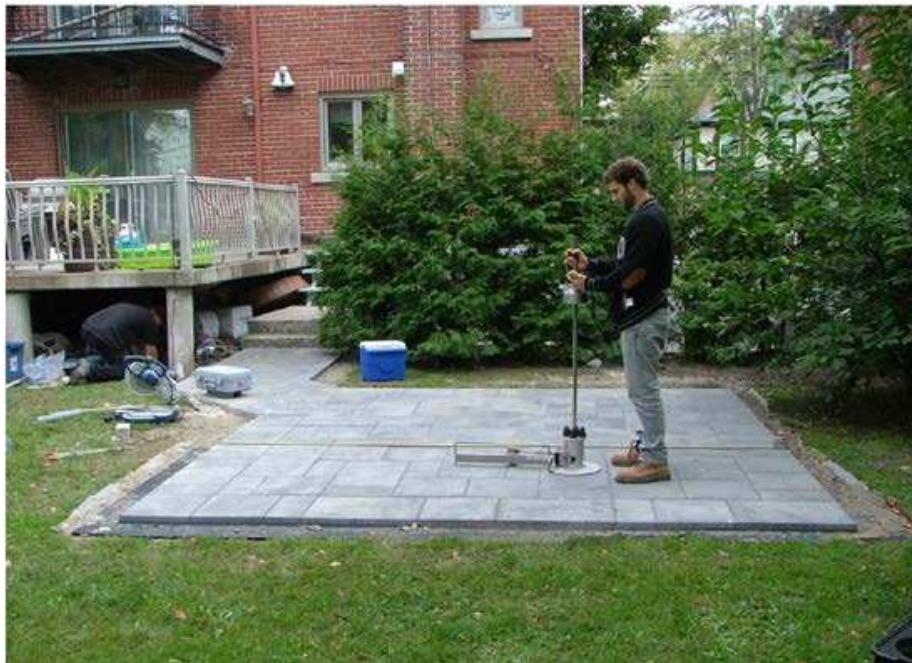
**Picture 3** 204 Dufferin Avenue in Hampstead - Backyard patio position 206° SW surrounded by a house side hedge and mature trees in the back.

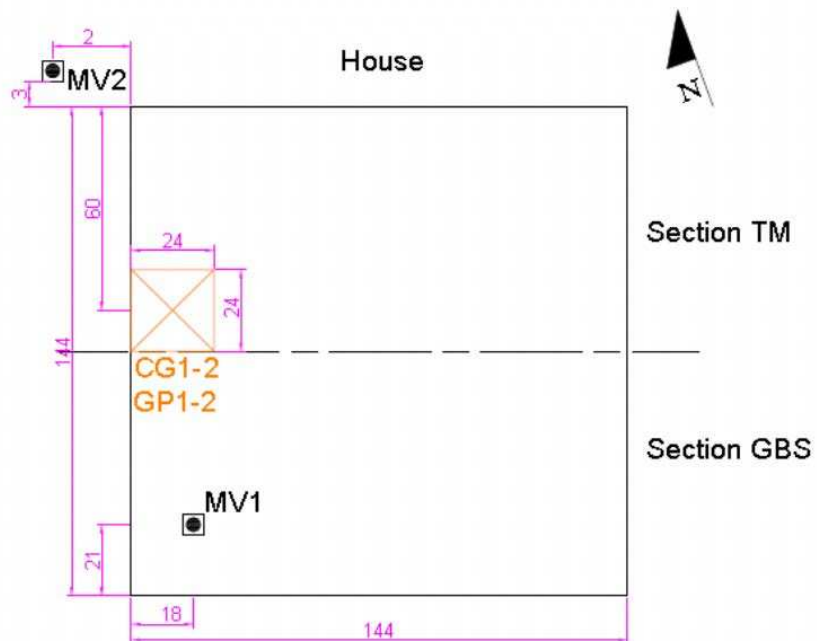
Figure 7 Sample location at 204 Dufferin Avenue in Hampstead.

Following the removal of turf and topsoil (GBS) and the complete excavation (TM) of the sections on the residential property, several soil samples were taken manually. These samples were taken to obtain materials for the tests of: 1) Gradation and Proctor ( $GP_x$ ), 2) Density ( $MV_x$ ), and 3) Segregation potential evaluated with a freezing cell ( $CG_x$ ). The sampling locations for each site are shown in Figures 5, 6 and 7. A total of nine (9) samples were taken. In addition, the  $GP_x$  and  $MV_x$  samples were used for the tests of: 4) Water content, 5) Consistency limits, and 6) Compaction (or oedometric consolidation).

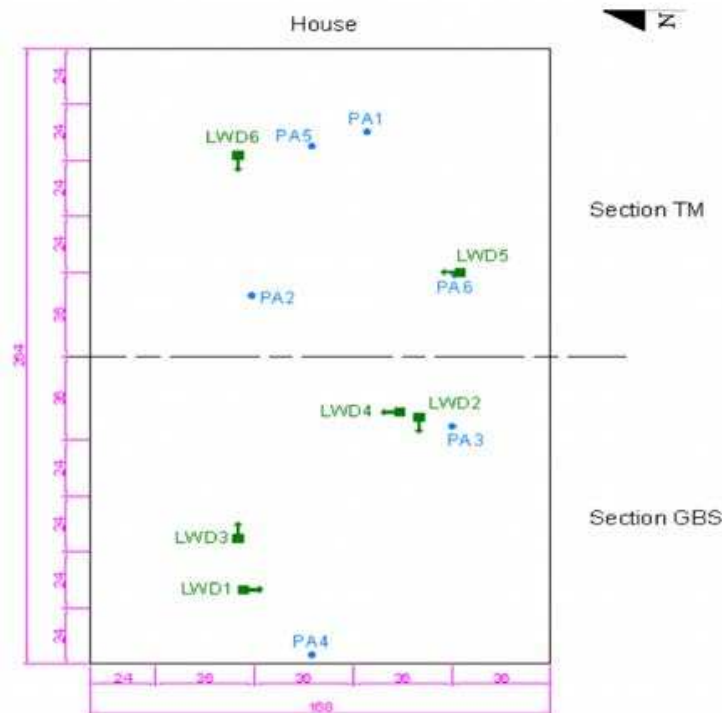
**Figure 8 Location of the Panda (PA) and LFWD (LWD) trials at 67 Roxton Crescent in Montreal West.**

For each site, variable energy light dynamic penetrometer tests (Panda, PA<sub>x</sub>) were performed (Figures 8, 9 and 10). These tests were first performed on uncompacted soil (CNS), then on compacted soil (SC) and finally on compacted crushed stone (PCC). The Panda consists of a metal rod that is driven into the ground (or stone) by manual beating in order to know the peak strength of the material as a function of depth and thus, to know the mechanical strength of the material. The peak strength varies according to the type of soil and its rigidity. With this device, it is therefore possible to define the stratigraphy (location of the different layers) of a site according to its peak strength. In addition, the resistance at the tip of the ground can be converted into mechanical resistance (resilient module, Mr).

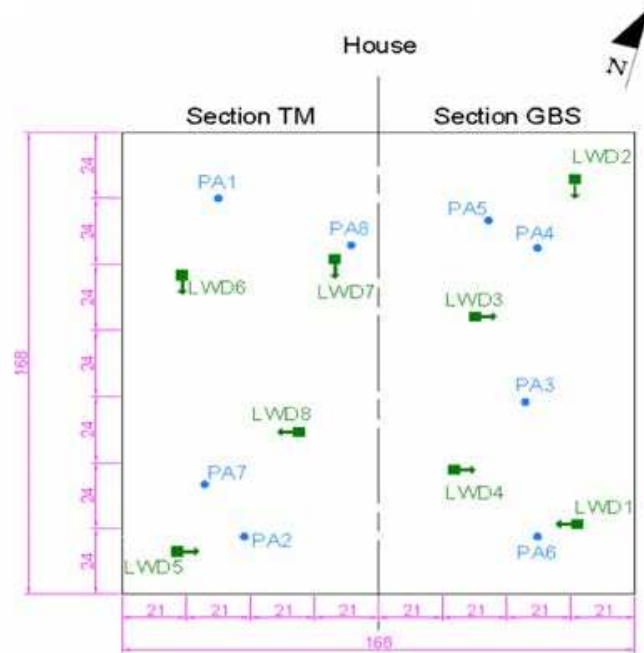
**Figure 9** Location of the Panda (PA) and LFWD (LWD) trials at 114 Daigneault Street in Chambly.

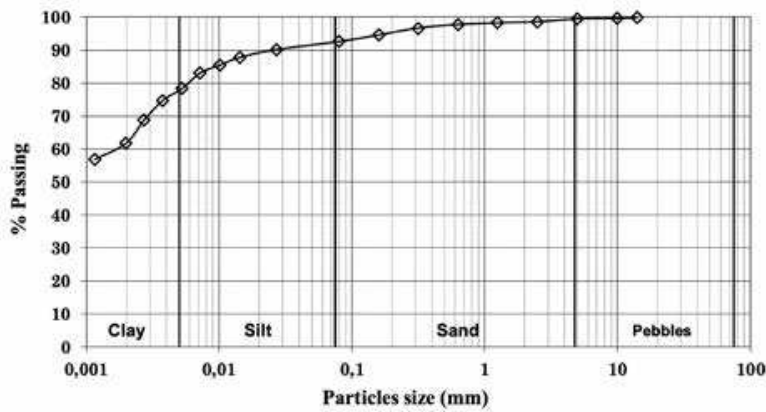
**Figure 13 Results of sieving and sedimentation analyses for the soil at 114, Rue Daigneault in Chambly.**

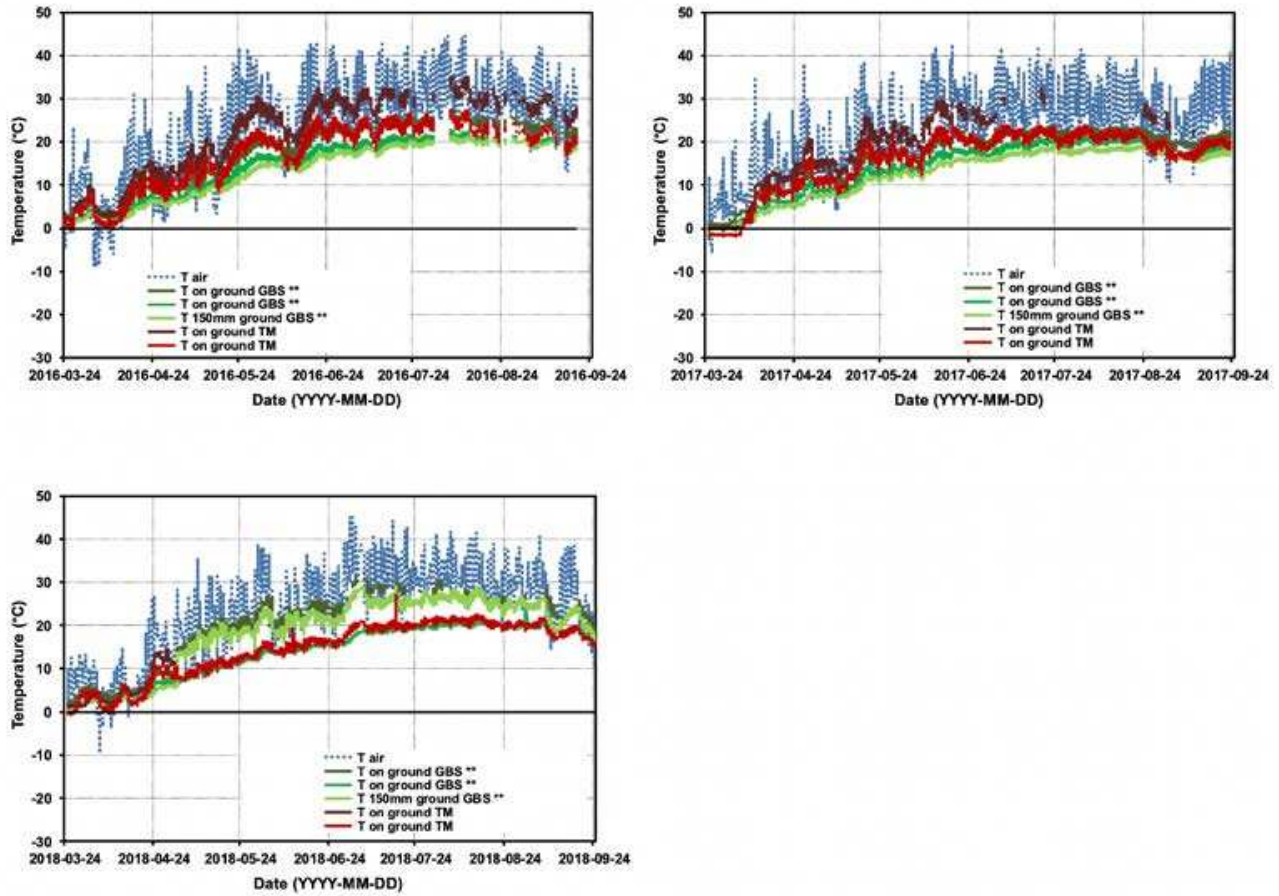
**Figure 16** Temperature readings during the hot period at 67 Roxton Crescent in Montreal West.

Figure 16 shows the temperatures recorded from September 24, 2015 to December 19, 2018, for the warm periods of the year, from April to September. Again, the temperatures recorded for the TM section vary more than those recorded for the GBS section. This means that the GBS section offers better thermal insulation. Overall, for this period, the temperatures associated with the GBS are lower than those of TM.

These results must be qualified, however, because the layout of the patio to the various elements of the yard (house, furniture, air conditioning, shrubs, hedges, fence, etc.) can have an effect on air movement and sun exposure leading to localized temperature variations that have an impact on the measurements.

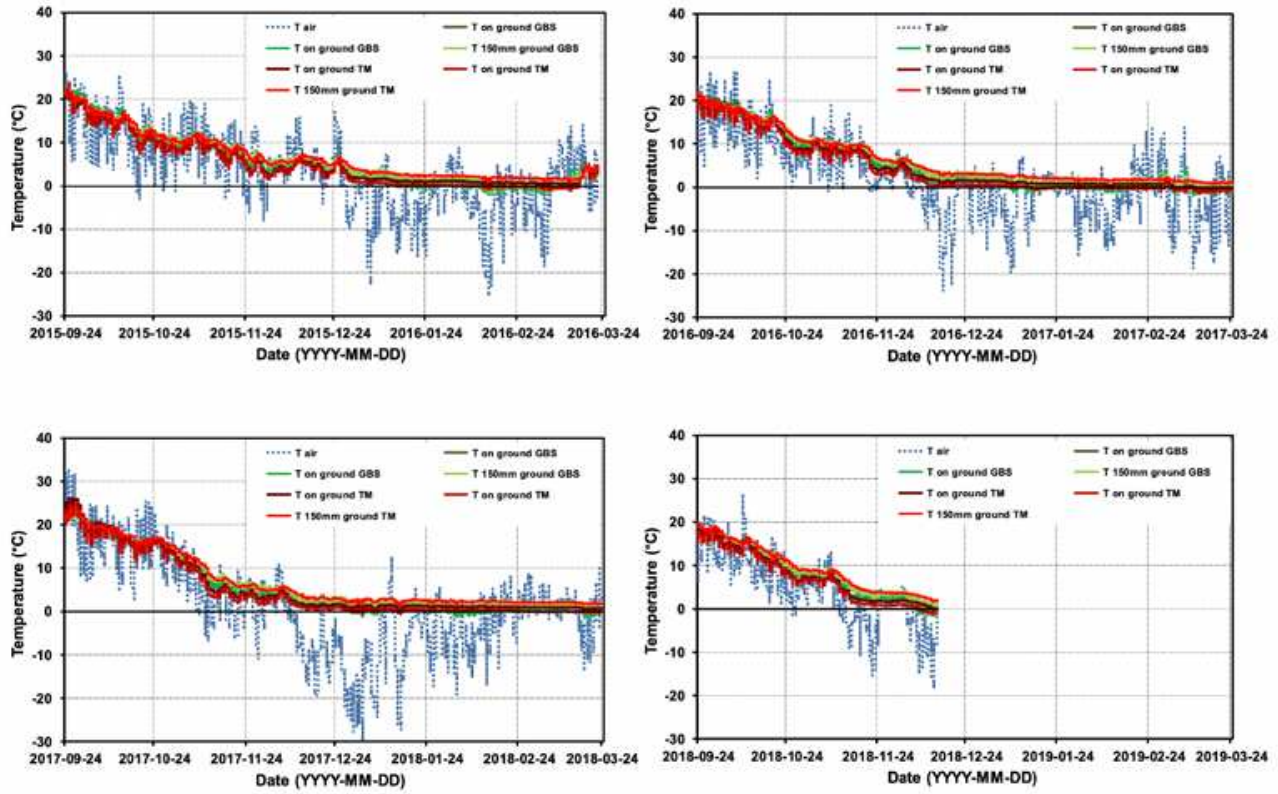
**Figure 17** Temperature readings during the cold period at 114, Rue Daigneault in Chambly.

For Site 114, cold weather temperature readings from September to April for the entire duration of the survey, from September 24, 2015 to December 19, 2018, are shown in Figure 17. In addition, Figure 18 shows the temperatures for the periods from April to September and for the entire duration of the surveys. Tables 12 and 13 summarize the temperature readings for Site 114 during cold and warm periods, respectively. On this site it can be seen that the temperatures at the surface of the infrastructure ground and at 150 mm depth are very similar for both systems, for both cold and hot periods. These results confirm the superior insulating power of the GBS compared to the much thicker TM.

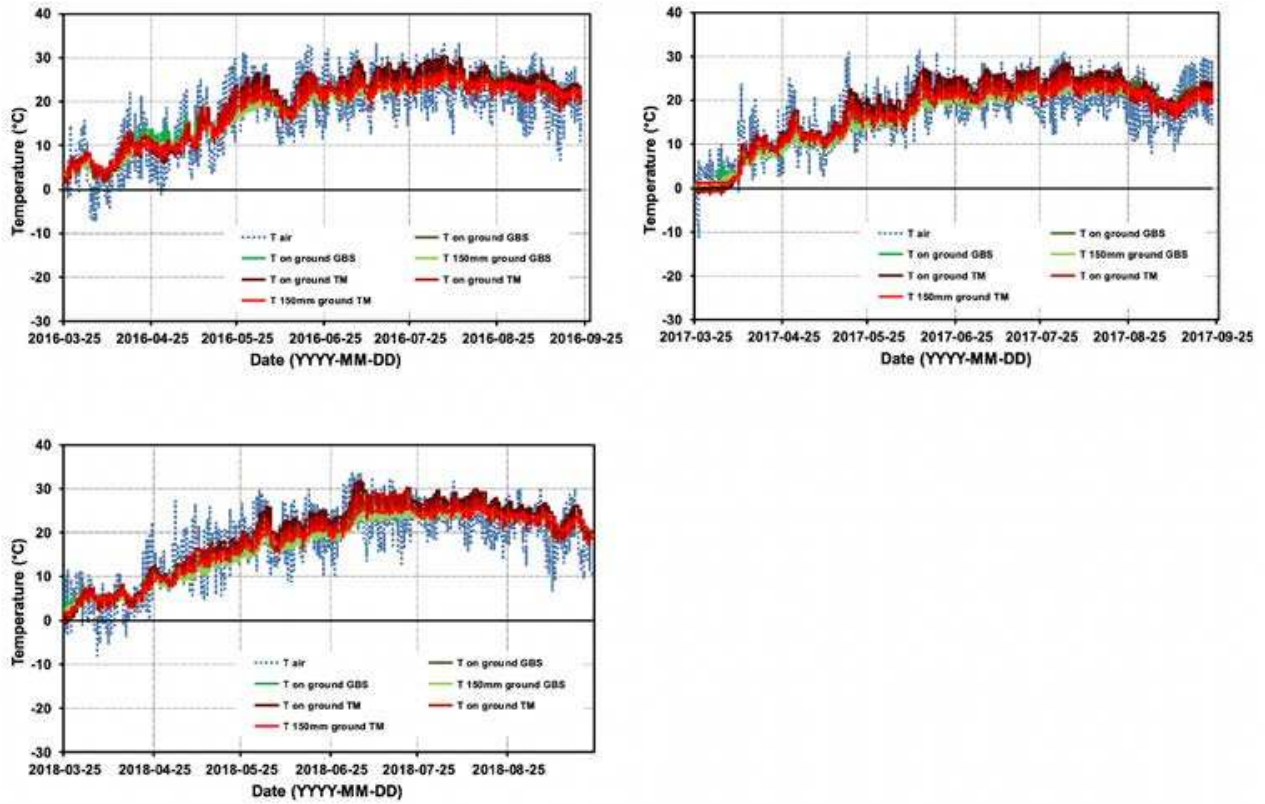
Figure 18 Temperature readings during the warm period at 114, Rue Daigneault in Chambly

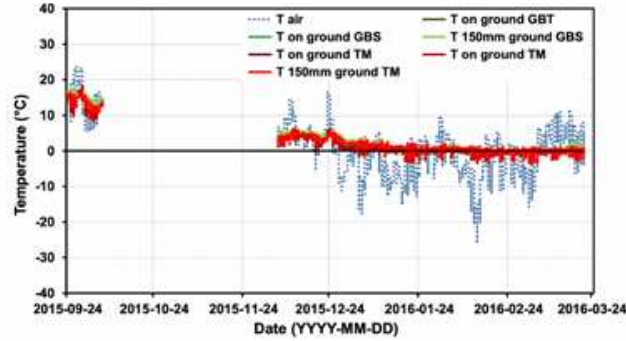
**Figure 19** Temperature readings during the cold period at 204 Dufferin Avenue in Hampstead.

For Site 204, the results obtained for the total duration of the surveys are incomplete. Indeed, the data acquisition system has failed and the few attempts made to correct this problem have been unsuccessful. Nevertheless, the results are presented in Figures 19 and 20, and the same trend can be observed as at site 114, i.e. very similar temperatures for both systems.

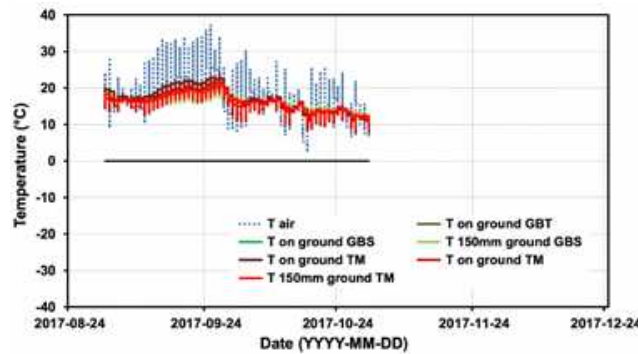
**Figure 20** Warm weather temperature readings at 204 Dufferin Avenue in Hampstead.

Tables 14 and 15 provide a summary of the temperature readings available for Site 204. These tables indicate that the temperatures recorded for the GBS section (green color values) vary just a little more than those recorded for the TM section (red color values).

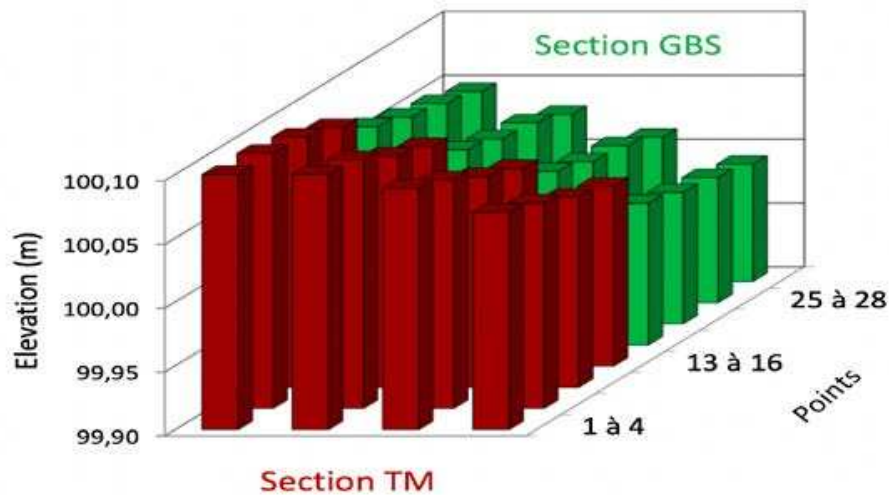
Figure 24 The initial profile of the sections at 67 Roxton Crescent in Montreal West.

The analysis of the results is done in a relative way, i.e. the surface deformations for each of the sites are evaluated on the basis of the initial surface. Using the 1st survey, the initial profile of the sections can be established. Figures 24, 25 and 26 illustrate the initial profile of the sections for each site. The elevation value of the sections is relative to the arbitrary elevation, but it allows appreciating the high and low points & slopes used during the construction of the sections. In addition, it allows following the fluctuations of the surface at each reading and this always in relation to the initial elevation. For all sites, the elevation analysis reveals that water flow on the surface of the paving stones will necessarily occur towards the GBS sections (Figures 24, 25 and 26).

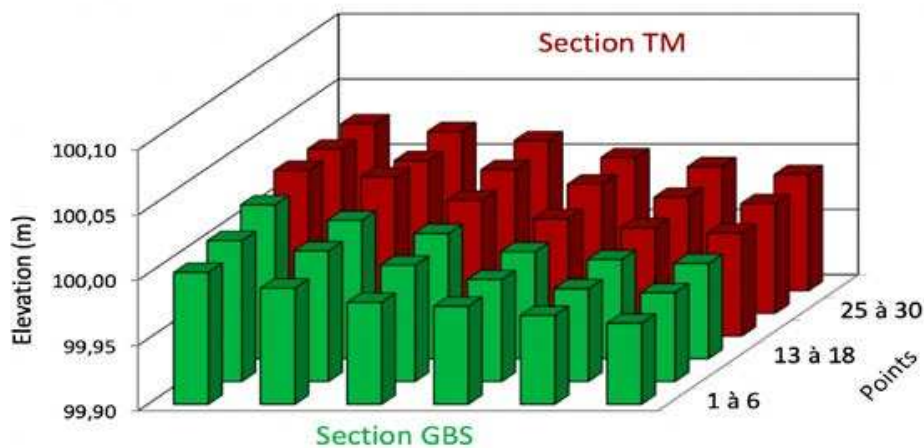
Figure 25 The initial profile of the sections at 114, Rue Daigneault in Chambly.

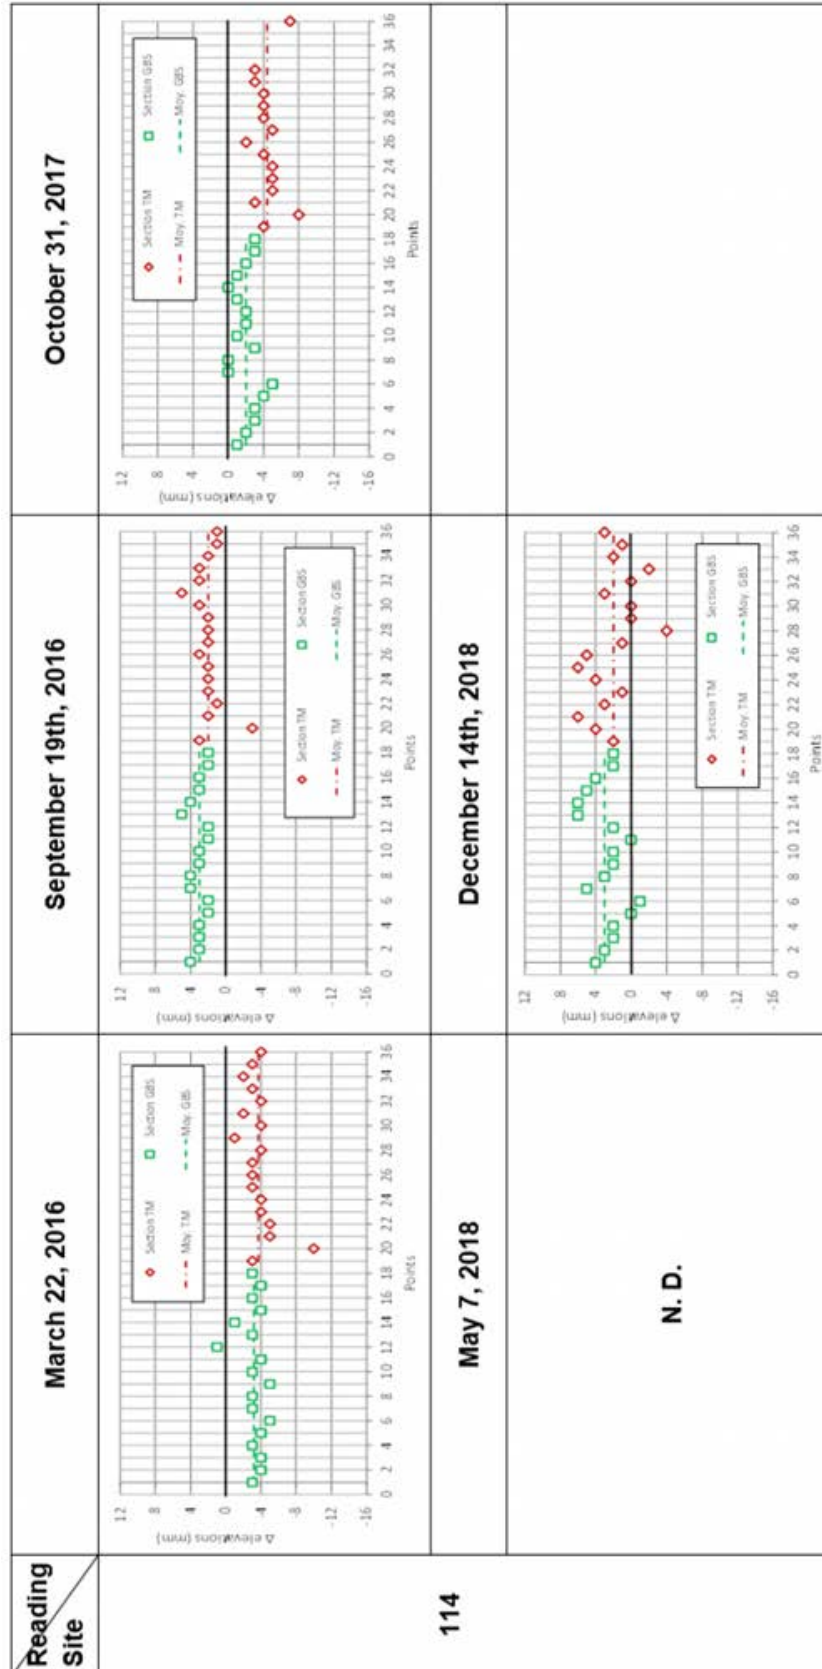
**Figure 29 Elevation deviations for the entire survey period on site 114 Daigneault Street, Chambly**

Analysis of the elevation data for site 114, presented in Figure 29, shows very small deformations, in the order of 4 mm of settlement for both systems. For this site, spring 2018 data are missing. In the fall of 2018, there was heavy precipitation, cold and early frost, as shown in Figure 16. This may explain the 4 mm to 6 mm lifts observed for both systems.
